INFLUENCE OF THE TURBOGENERATOR DAMAGE ON THE RELIABILITY OF ITS OPERATION

Geraskin O.A., Ph.D., Associate Professor, Mikityuk O.Y., Bachelor
Igor Sikorsky Kyiv Polytechnic Institute, Department of Electromechanics

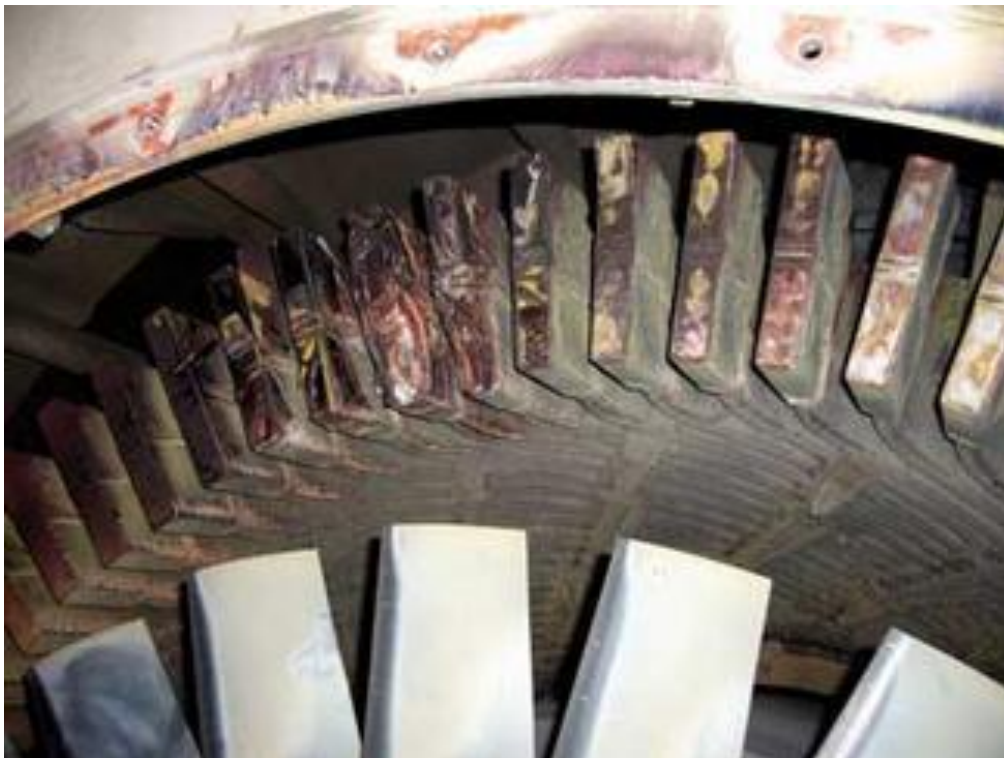
In 2009, at the Sultan Ismail power plant located in Terengganu in eastern Malaysia, a 124 MVA Toshiba generator, which was commissioned in 1984, failed. In particular, the loss of cooling water led to overheating of the generator, which caused the melting of the soldered joints of the stator windings (Fig. 2). These electrical connections in the stator winding allow current to flow from one stator rod to another. Overheating caused leakage of solder from the joints, interruption of current flow, melting of copper from the stator conductors, damage of the stator bus insulation. The generator was turned off due to the operation of automation. The most negative phenomenon for the turbogenerator and the power plant unit as a whole is the depressurization of the cooling system, including stator winding, which can lead to hydrogen detonation and, as a consequence, to the destruction of the power plant unit [5].

Figure 2 – Damage of the front part Toshiba TG stator winding insulation with a capacity of 124 MVA [4]

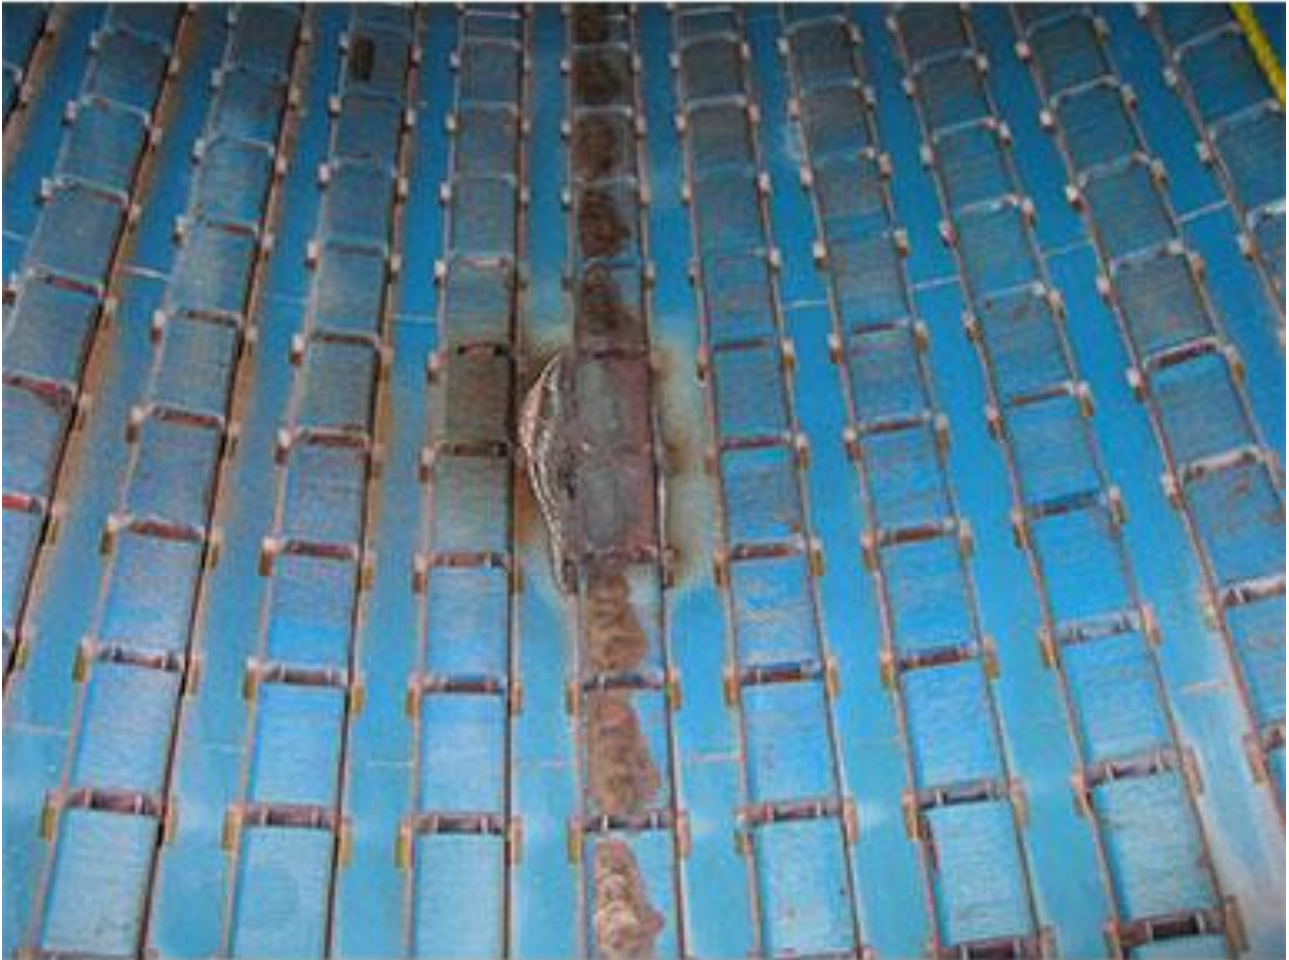
Damages of the stator and rotor windings insulation. Good insulation quality is one of the main prerequisites for proper operation and high performance of generators. Local "hot spots" in the TG core and overheating of the insulation cause not only premature aging of high-voltage insulation of the stator and rotor windings, but also damage of the core package, due to which the TG must be removed for repair (Fig. 3). On average, increasing the temperature every 10 degrees reduces the duration of insulation aging by half [7].

Figure 3 – Burnout of TG stator winding, which led to damage to the core package [6]

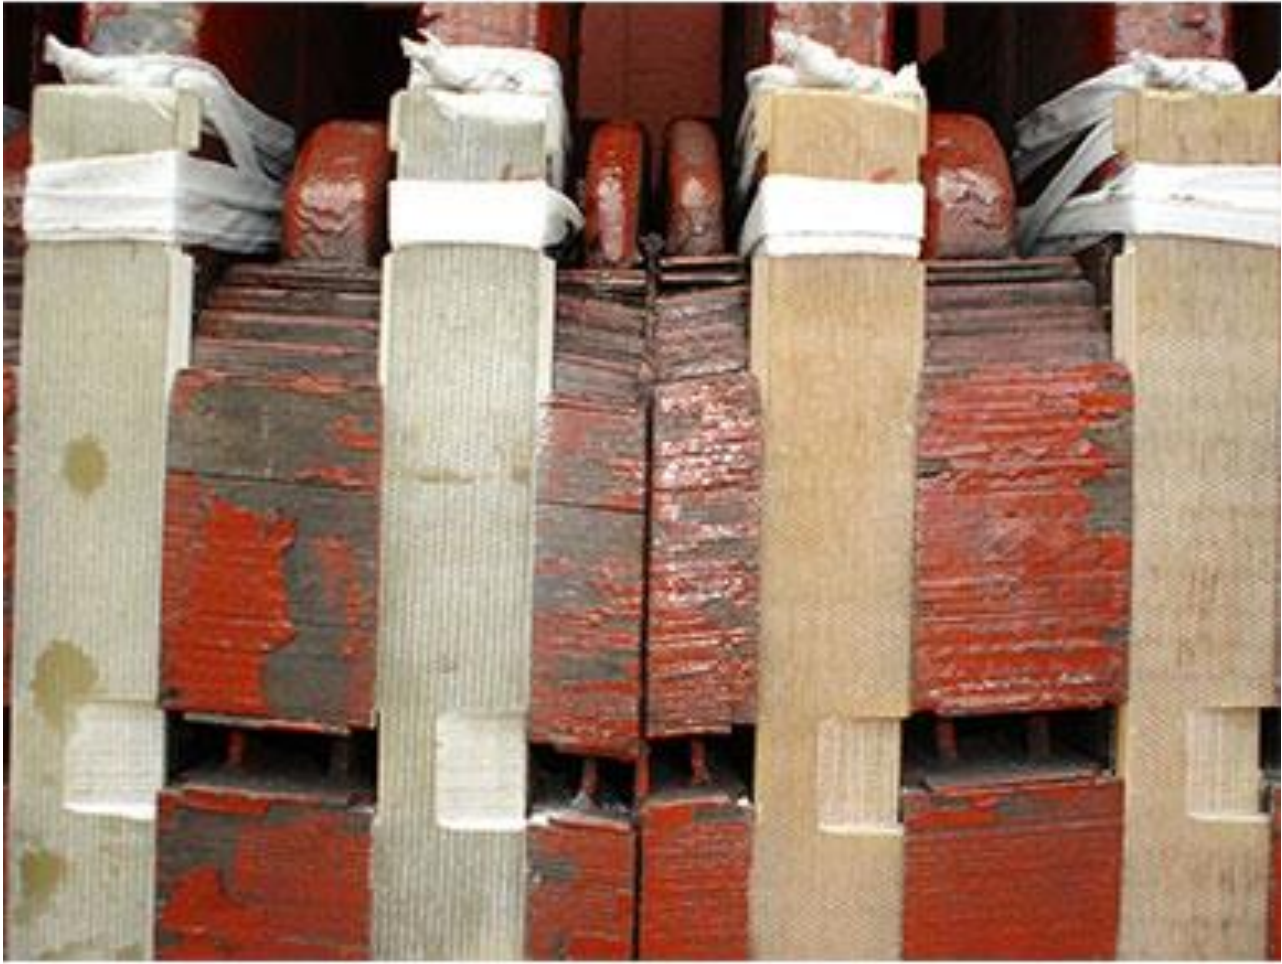
Mechanical deformation of the core is mainly caused by the lack of sufficiently reliable fastening of the stator core plates or the core segments deformation in large machines with a segmented core design. Cores made of several segments (usually from two to eight) can be damaged in the area of their connection due to the movement of a core sections (Fig. 4). In addition, the metal components, which for some reason got into the air gap, can also mechanically damage the core of the TG. Lack of sufficient compression of the core in the presence of large magnetic forces can cause relative displacement of the plates and damage of the winding insulation by abrasion, which will lead to a short circuit and the appearance of an electric arc [6].

Figure 4 – The stator core end damage [6]

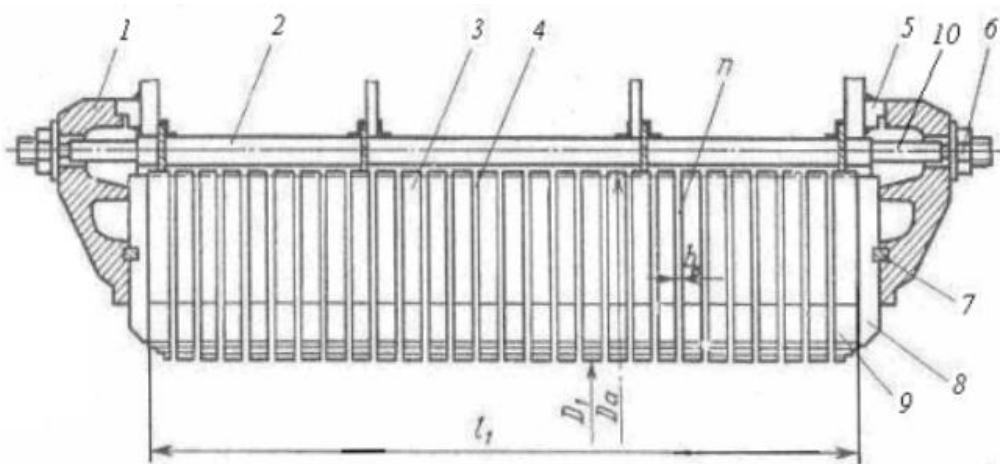
Insufficient strength or incorrect installation of pressure fingers of turbogenerators. The main reason for the mass occurrence of steel defects in the stator cores of turbogenerators type TVV-320-2 is the lack of reliability and strength of the pressure fingers (Fig. 5). The same reason for the insufficient level of reliability is observed on turbogenerators such type as TVV-1000-2. The margin of safety in the pressure fingers only from the action of static pressure of the press is only 14% [8]. This defect in the manufacture of the core is usually detected visually, as it leads to plastic deformation and/or displacement of the fingers from the initial position. Such damage leads to breakage of the glued packages of the stator core, tooth sheets and wear of the ventilation spacers of the turbogenerators.

Damage of the studs and breakage of the coupling prisms of turbogenerators. During of turbogenerators work or their repair damages of studs and breaks of coupling prisms of a stator can take place (fig. 5). The process of the coupling prisms damage leads to significant material and financial losses. The main causes of damage are increased vibration, cyclic thermomechanical stresses under variable load modes and the phenomenon of metal fatigue on the heads of coupling prisms [9].
