INDUCTION MOTORS SQUIRREL-CAGE ROTOR WINDING DAMAGES

Nesterenko D.S., master, Geraskin O.A., Ph.D., associate professor
Igor Sikorsky Kyiv Polytechnic Institute, electromechanics department

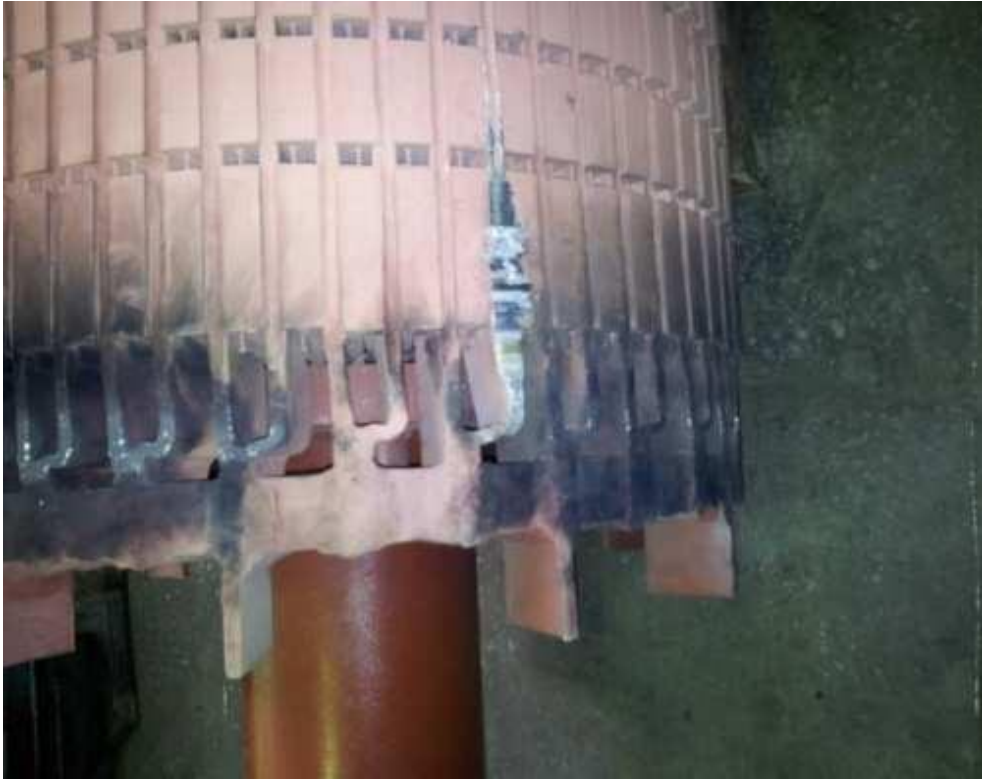
- *Significant electrodynamic issues during motor start.* Fig. 2 shows the output of the rod from the slot due to the action of the electrodynamic forces when starting the motor. It is worth to note that this motor was operated in extremely hard starting conditions, although it was not designed for such operation modes [2].

Figure 2 – The output of the rod from the slot due to the action of the electrodynamic forces when starting the motor

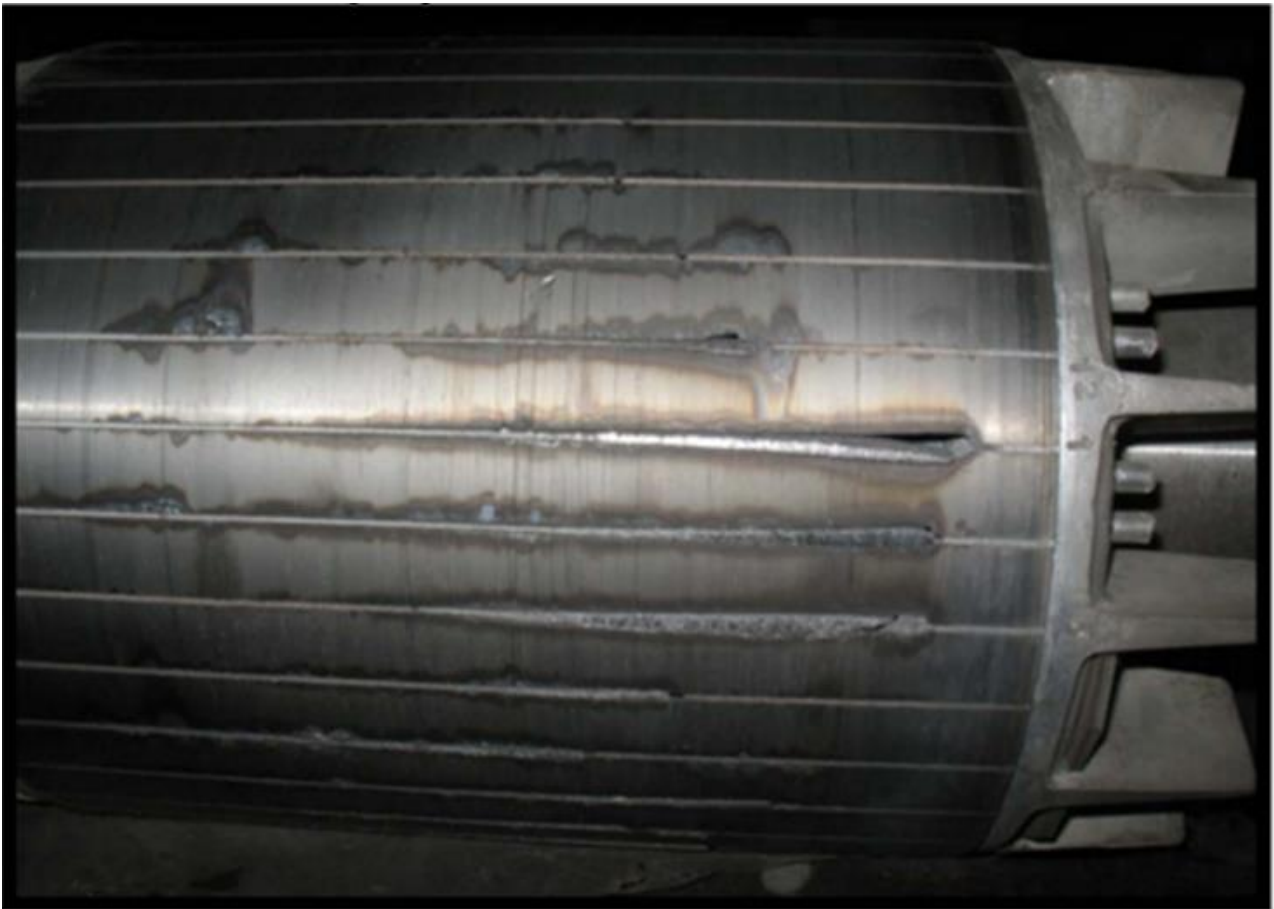
• *Frequent restarts of the IM in the heated state.* Under such operation conditions, the overheating of the winding (Fig. 4) reaches the highest values, especially in motors with hard starting conditions, which can lead to the damage, in particular the melting of the SC rotor material from the slot [1].

Figure 4 – Thermal damage of the rod of the SC rotor due to frequent restarts in the heated state.

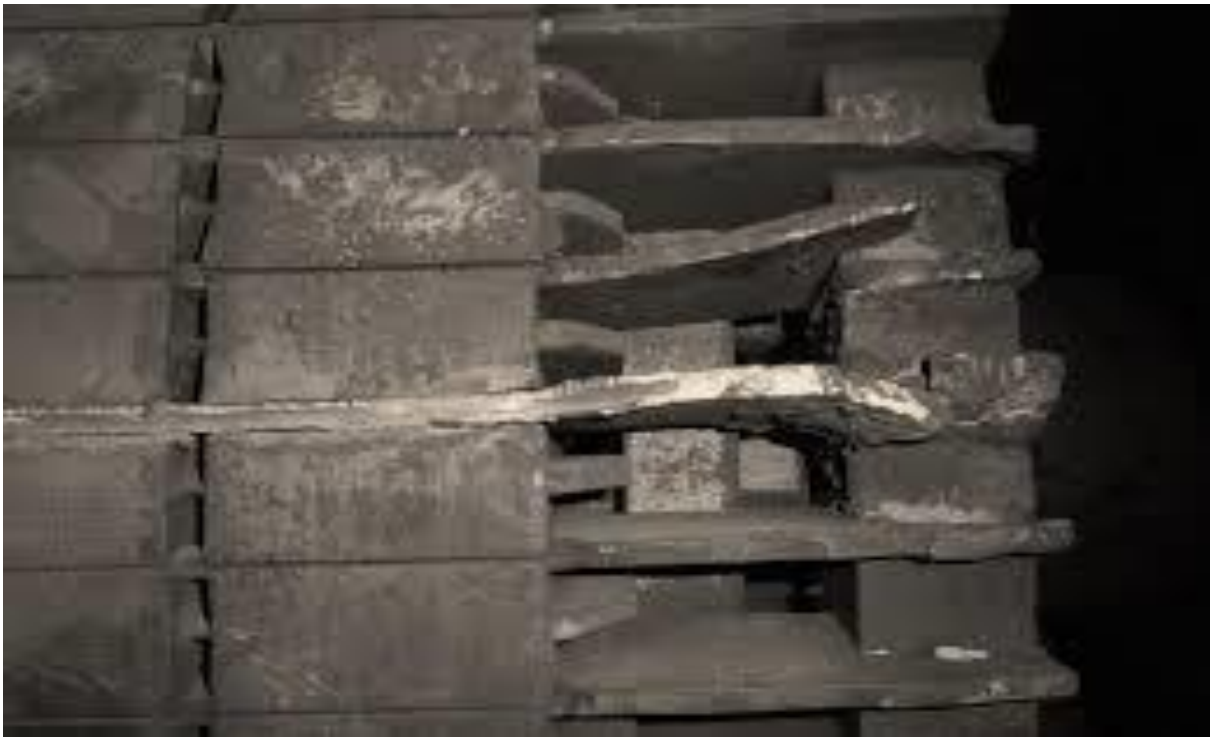
One of the most common reasons of the damage of the IM rotor winding is the separation of the rotor rods from the short-circuited ring.

At the initial stage, the breakout of the rotor rod has almost no effect on the operating characteristics of the motor and can't be detected immediately. When the rod breaks, the load is redistributing to the other conductors (winding rods). The main load is redistributed to the rods, adjacent to the broken, creating the abnormal operation conditions of the rotor. Thus, the breakout of the one rod often leads to the damage of the other rods. Later on, the broken rod can bend (usually during motor start) and damage the stator winding, which will lead to serious consequences for the motor, which requires the major repairs or replacement of the damaged IM with a new one.

Fig. 5 shows two rods that separated from the short-circuited ring and bent under the action of the significant electrodynamic forces [5].

Figure 5 – Separation of rods from the short-circuited ring

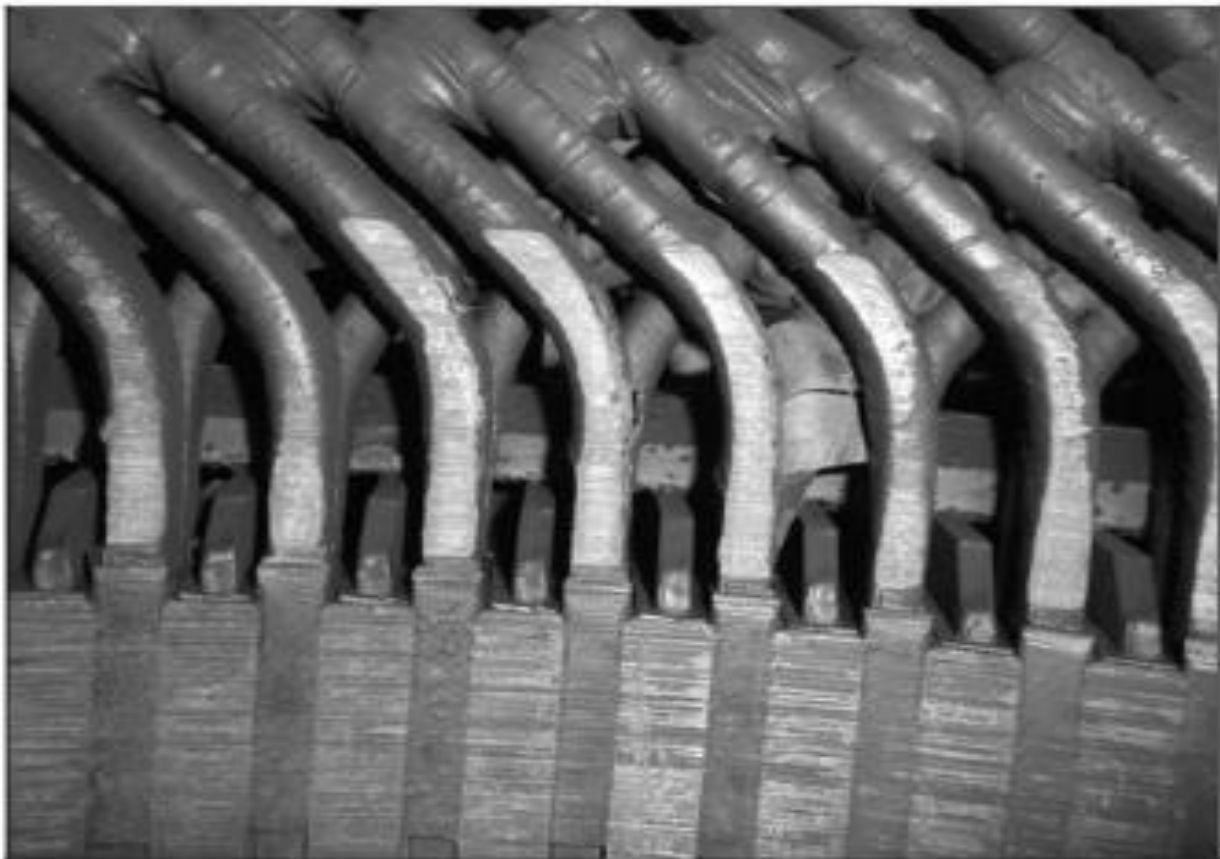
Fig. 6 shows the stator winding, on which is clearly seen the damage caused by bent rods [5].

Figure 6 – Stator winding damaged by the bent rods
