ROTOR STRUCTURE ELEMENTS DAMAGE OVERVIEW OF THE SALIENT POLE SYNCHRONOUS HYDROGENERATOR

Galisevych S.I., bachelor, Geraskin O.A., associate professor

Igor Sikorsky Kyiv Polytechnic Institute, Department of Electromechanics

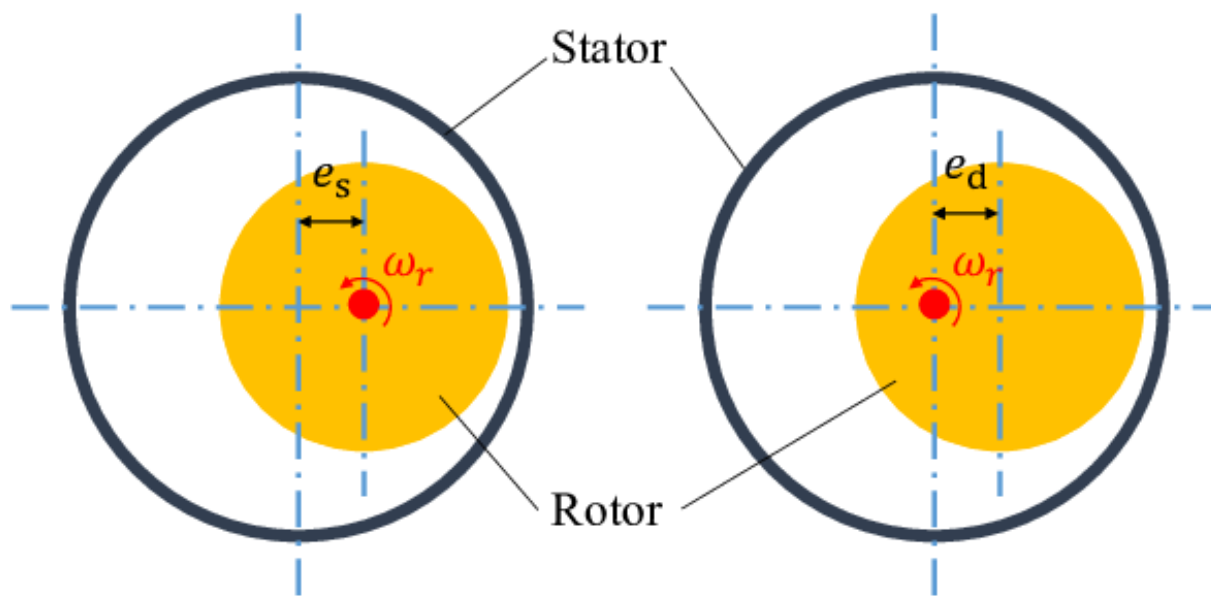
The eccentric position of the rotor in the stator bore is the cause of both static and dynamic rotor asymmetry in the HG air space (Fig. 2), which can cause significant forces of one-way movement between the rotor and the stator.

Figure 2 – Eccentric motion of the rotor in the stator boring at static and dynamic eccentricities of the rotor [2]

At high eccentricity, these forces can reach tens of tons and cause unilateral heating of the segments of guide bearings and even their failure. In addition, due to the eccentric position of the rotor in the stator boring, the rotor poles alternately fall into areas of small and large air intervals and can be exposed to significant dynamic forces, which can reduce the mechanical strength of the rotor parts and, consequently, change the shape of the rotor. The eccentric position of the rotor in the stator bore is manifested in the shift of the rotor during its operation and the unilateral pressure on the segments of the generator bearings towards the smaller air gap of the generator. The eccentricity can be the result of poor centering of the generator, changing the shape of the stator, or its radial shift over the foundation slabs during operation. Eccentricity can be avoided by centering the hydraulic unit. When the eccentricity is significant, the stator frame must be shifted. However, since the displacement of the stator and the correction of its shape are quite time-consuming operations, they are rarely performed. As a rule, the centering of the rotor and stator is limited to the possibility of entering the water wheel without displacement of the stator. The electrical imbalance of the HG rotor is usually a consequence of the rotational asymmetry of the rotor's magnetic field. In its turn, the latter can be caused by various structural reasons (for example, hydrogenators of Cheboksary and Nyzhniokam hydroelectric power plants were manufactured at the plant "Electrosila" with an increased interpolar distance [3]), installation causes (assembly of the rotor with deviations exceeding the permissible range) and operational factors (appearance of short-circuit). The presence of rotating asymmetry of the magnetic field of the rotor is manifested in the form of vibration of the stator core and the HG cross or in the form of a shaft beat on the generator bearings (in case of a significant electrical imbalance of the rotor, this can affect the bearing of the turbine of the hydraulic unit). Short circuits of coils in the winding of the poles can cause the appearance of low-frequency radial vibrations of the stator core. However, such defects are relatively rare. In addition, they are easy to detect and eliminate by simply replacing
